Manhole Inspection Summary

Manhole # S09MM1001MH

Insp Date: **12/19/08 11:27 AM**

Location Address: **4838 PARK HEIGHTS AVE**

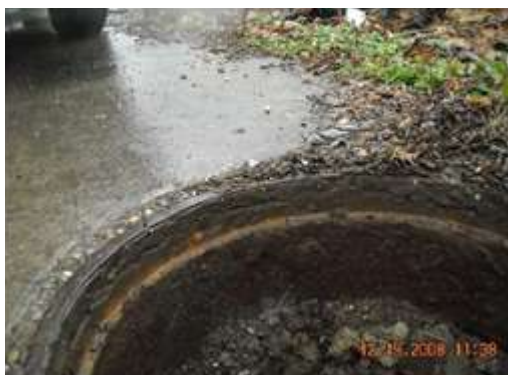
Subject To Ponding: **Sheeting**

SHEETING

EVIDENCE OF INFLOW DUE TO SHEETING

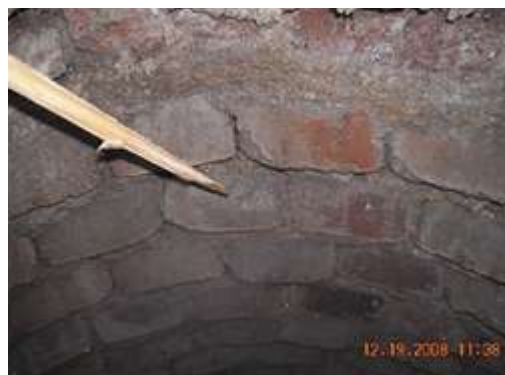
Defect 3

Condition: ☐ Sound ☐ Cracked ☐ Root Intrusion ☐ Loose Brick ☒ **Deteriorated**

DETERIORATION OF CORBEL WALL

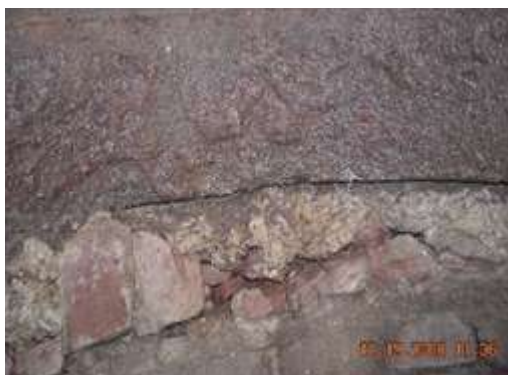
Defect 2

Condition: ☐ Sound ☒ **Cracked** ☐ Root Intrusion ☐ Loose Brick ☒ **Deteriorated**

CHIMNEY IS CRACKED AND DETERIORATED

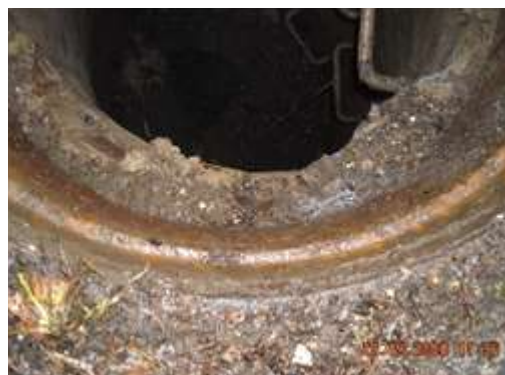
Defect 1

Offset: **2.5** (in.)

FRAME OFFSET 2.5"

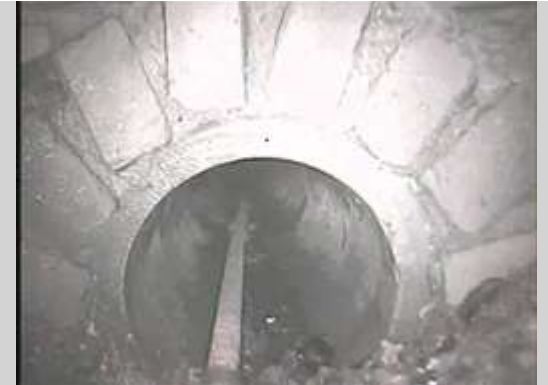
12 O'Clock Outflow

8 in. Circular Gravity Sewer
Pipe Out @ 12 O'Clock

Deposits: ☐ None ☐ Mud ☐ Sludge ☒ **Debris** ☐ Grease

Silt Depth: **1** (in.) Deposits Extent: **Light**
